Inspection Report

West 21st Street
New York NY

Five Borough Home Inspection, LLC

Date: 3/22/2013	Time: 1:30 PM	Report ID: 3222013
Property: West 21st Street New York NY	Customer:	Real Estate Professional:

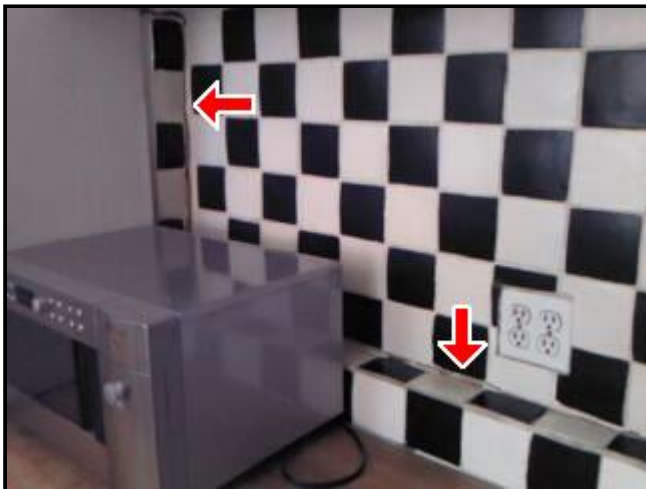
1.1 Picture 1

(1) The tiled wall behind the kitchen sink needs repair.

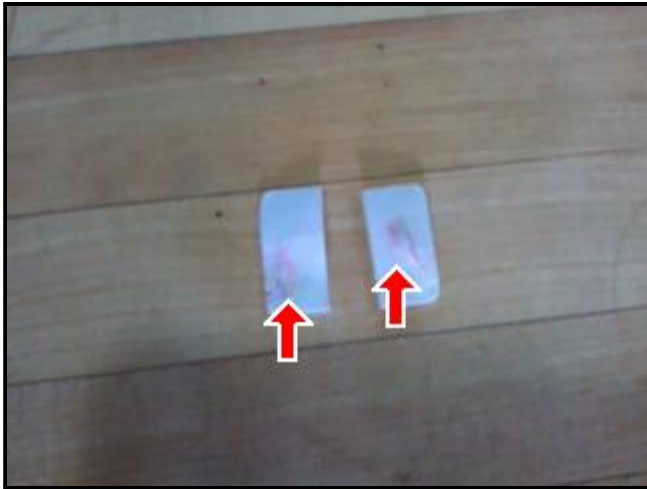
1.1 Picture 2 lead swabs

(3) We conducted two swab lead tests, one on a plaster wall and another on a baseboard. Both had a positive lead paint result. This was not a surface paint test. We cut through all layers of existing paint at the site and then swabbed to detect from underlying layers. See red positives on the photo. Like every home constructed before 1978 in the United States this apartment contains lead paint. There are two primary sources of lead paint contamination in such homes. The first and most significant is from original wood windows. All of the windows in this apartment are replacement thermopane and present no lead hazard. The second source is from peeling or flaking paint on walls and trim. The condition of all walls and trim in this apartment is excellent. There is no evidence of any deteriorated conditions that would result in contamination. Please be advised that any construction work conducted in this apartment should be done in accordance with the NYC Lead Law and OSHA standards of practice.

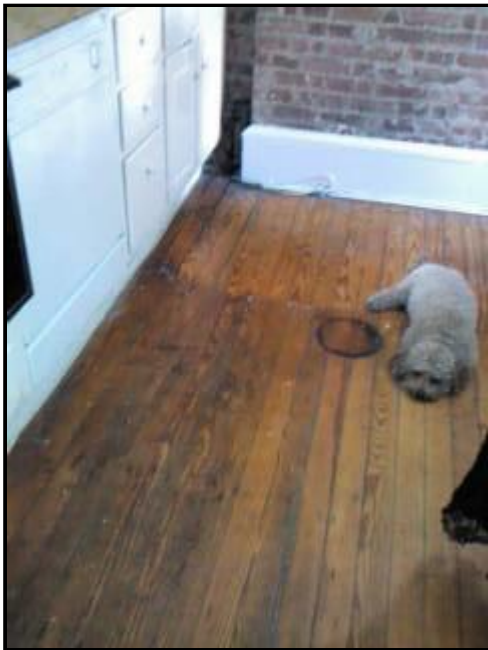
1.2 Picture 1 kitchen floor

(1) The kitchen floor requires refinishing.

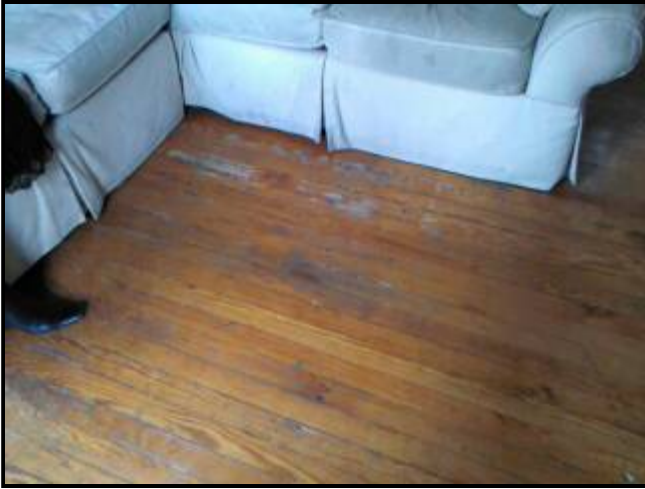
1.2 Picture 2

(2) The living room floor needs refinishing.

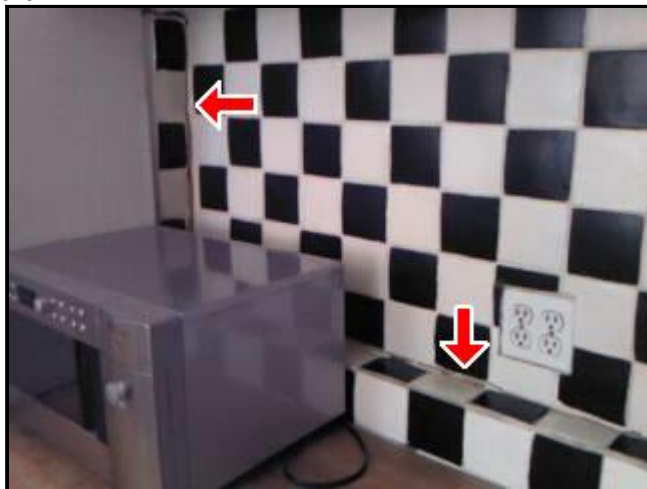
1.1 Picture 1

(1) The tiled wall behind the kitchen sink needs repair.

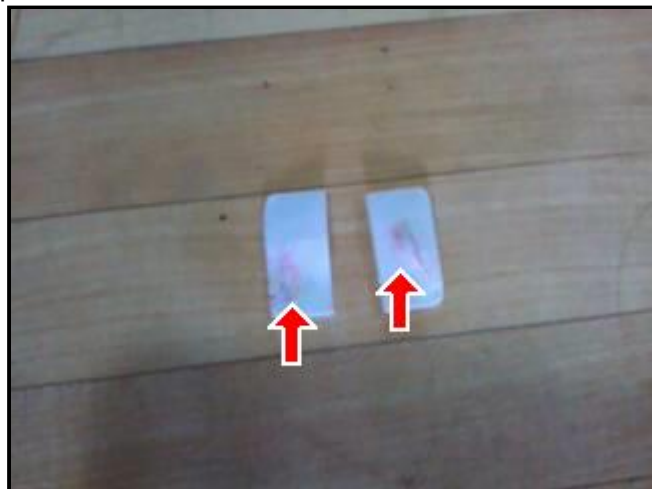
1.1 Picture 2 lead swabs

(3) We conducted two swab lead tests, one on a plaster wall and another on a baseboard. Both had a positive lead paint result. This was not a surface paint test. We cut through all layers of existing paint

at the site and then swabbed to detect from underlying layers. See red positives on the photo. Like every home constructed before 1978 in the United States this apartment contains lead paint. There are two primary sources of lead paint contamination in such homes. The first and most significant is from original wood windows. All of the windows in this apartment are replacement thermopane and present no lead hazard. The second source is from peeling or flaking paint on walls and trim. The condition of all walls and trim in this apartment is excellent. There is no evidence of any deteriorated conditions that would result in contamination. Please be advised that any construction work conducted in this apartment should be done in accordance with the NYC Lead Law and OSHA standards of practice.

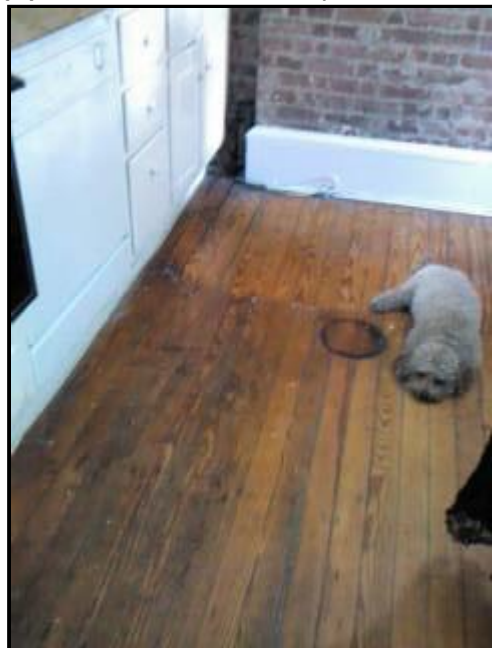
1.2 Picture 1 kitchen floor

(1) The kitchen floor requires refinishing.

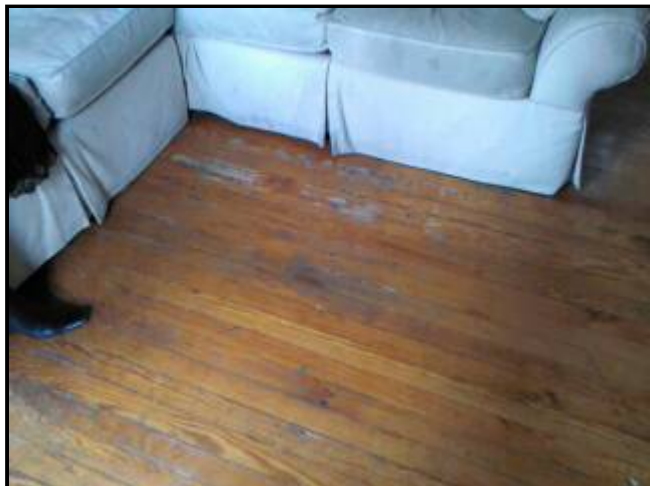
1.2 Picture 2

(2) The living room floor needs refinishing.
